Bicycle Parking Monitoring Pilot - Summary Report

WestTrans 2016

Bicycle Parking Monitoring Report

Report on the inspection of 71 West London developments with a cycle parking requirement in accordance with the London Plan and the quality of cycle parking available at each site. Sites were judged against the West London Cycle Parking Standards. On the whole, nearly all sites failed. Many did not provide any cycle parking at all. This report assumes the reader has knowledge of the London Cycle Design Standards or the West London Cycle Parking Guidance.

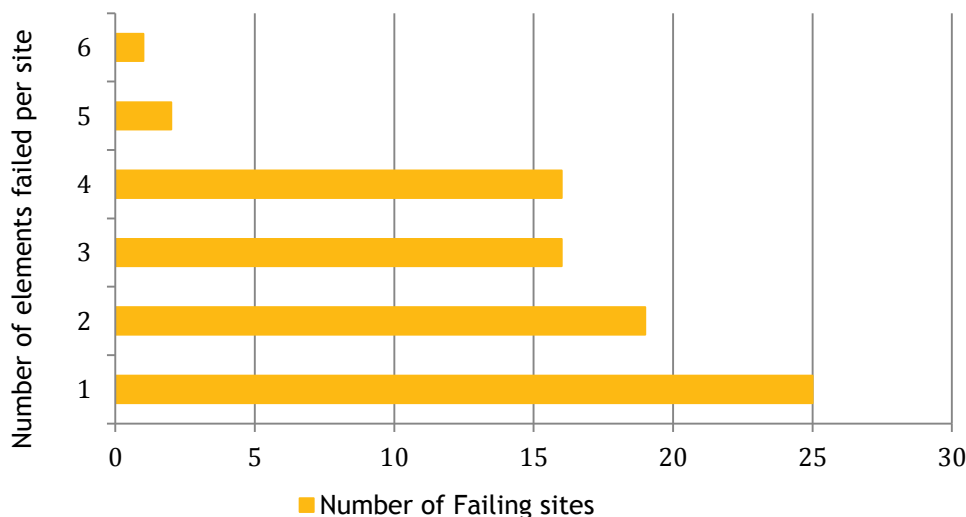
Figure 1. Number of elements failed per location

Excluding locations where cycle provision was not provided, most sites only failed because of one element and the most common element failed was spacing (figure 2.). This is because many cycle parking solutions are prefabricated multi-stand racks with centres set too narrow. Most manufacturers offer options on spacing, so spacing standards for these stands types can be met.

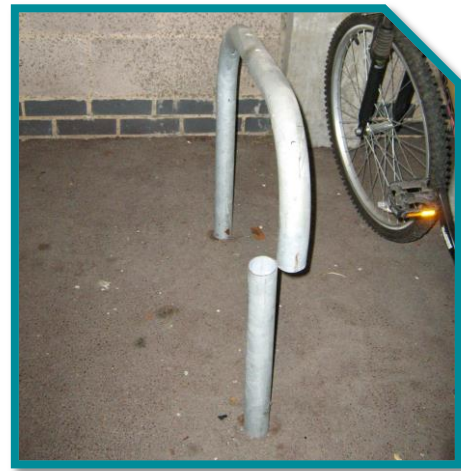
Figure 5.

Many sites did not offer secure areas for long term parking, that is, there was no extra protection given to bicycle security than that shared by the car users. Stands were located in the car park or where any site user could access. Evidence of bike theft within a closed basement parking area illustrated the need for a cycle-specific cage or room. In addition, cheap stands (inferior material construction) had been cut instead of the chain securing the cycle, figure 5.

Security issues are strongly related to location issues, especially for natural surveillance and personal safety fears. Cycle parking should not be in the corners of basement car parks or hidden from plain sight around the rear or sides of a building. This may be satisfactory for car users but cyclists cannot lock themselves in their bicycles like drivers can lock the door of their cars if they feel vulnerable.

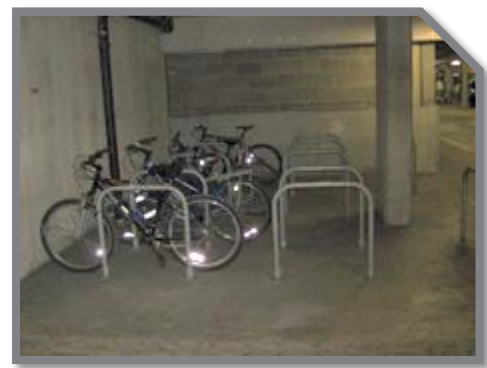
Figure 7.

Almost all residential developments had long term parking on site, however, most of it seemed to have been designed after the development was completed because the layout felt squashed, or small numbers of stands were placed in areas that couldn't be used for car parking. Indeed, most of them were located directly in the car park, among the car parking spaces, which made the inspector feel nervous and unsafe - fear of attack.

Element	Long Term Location
Location	Pass
Access	Pass
Spacing	Fail
Stand	Pass
Security	Fail
Maintenance	Fail

500 spaces provided, 97 in use.

H23 is a very large development (471 units and a hotel) with a double-storey parking area combining both car and cycle parking - this type of development requires a large number of cycle parking spaces. Although access, stands, spacing and the cycle parking location would meet the standards, the location of the stands among parked cars did not give a feeling of security. Additionally, the car park looked neglected in terms of maintenance, as did the cycle parking. Bikes were often dusty - to the point that some cyclists covered their bikes with motorbike covers.

Furthermore, considering the high number of spaces that had to be provided, the developer did not take into account the distance of each stand from the entrance and set out the cycle parking at increasing distances from the entrance. The result is that some stands were over 100 meters away, which caused the nearest stands to be overused (more cycles using a single stand than should), while those further away were not used at all. This example stresses the importance of planning cycle parking in large developments in separate storage clusters and not in the main car park as it presents a number of issues on maintenance, security and location.
